TROUBLESHOOTING GUIDE

Sigma Agriculture

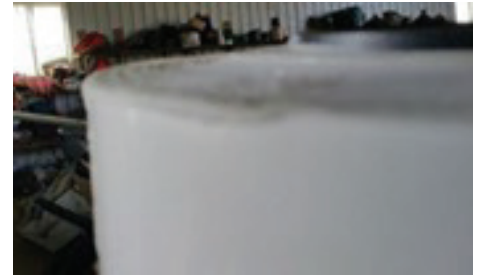
Issue: The roll was mishandled and has damaged. When rolls are dropped or damaged on the edge, the chance of film breaks increases dramatically.

Solution: Either pull the damaged film off the roll until undamaged film is exposed or replace the roll.

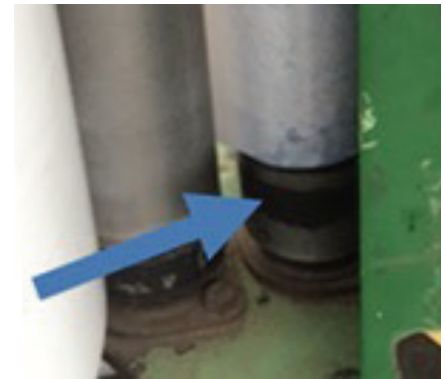
Issue: Over time the tackifier used in silage film will rub on to the rollers of the machine causing the rollers to be covered in a sticky, black residue.

Solution: Clean rollers with white mineral spirit or automotive brake cleaner. Make sure that all build up has been removed from the rollers and retest.

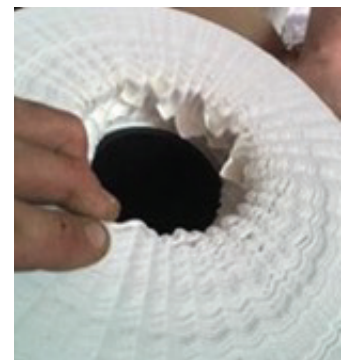
Winding Fault

Issue: Some of the ingredients used in the film can cause layers to slide between each other.

Solution: Unwind the film until any flaws have been removed. Try the roll again after unwinding. If the film is still unusable, please email us for technical assistance.

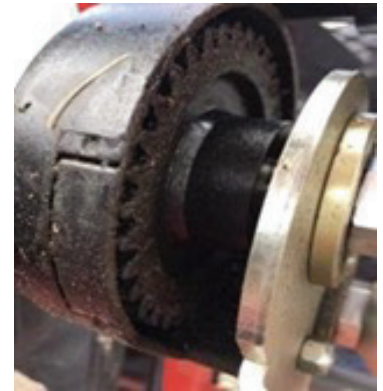
Worn Gears

Issue: Gears that have worn or been damaged can cause rollers to bind, which creates additional tension.

Solution: If the pre-stretch unit gears are worn or binding, they must be replaced. This ensures the film stretches properly without excessive resistance.

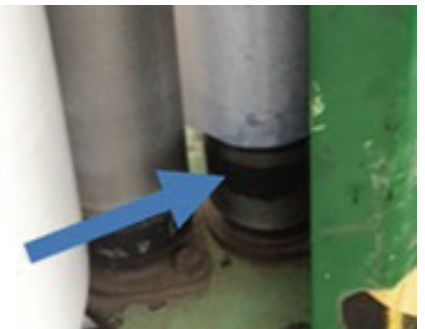
Build up on pre-stretch unit

Issue: Over time, the tackifier used in silage film will rub on to the rollers causing them to be covered in a sticky residue.

Solution: Clean rollers with white mineral spirit or automotive brake cleaner. Make sure all build up has been removed from the rollers and retest.
