TROUBLESHOOTING GUIDE

Sigma Agriculture

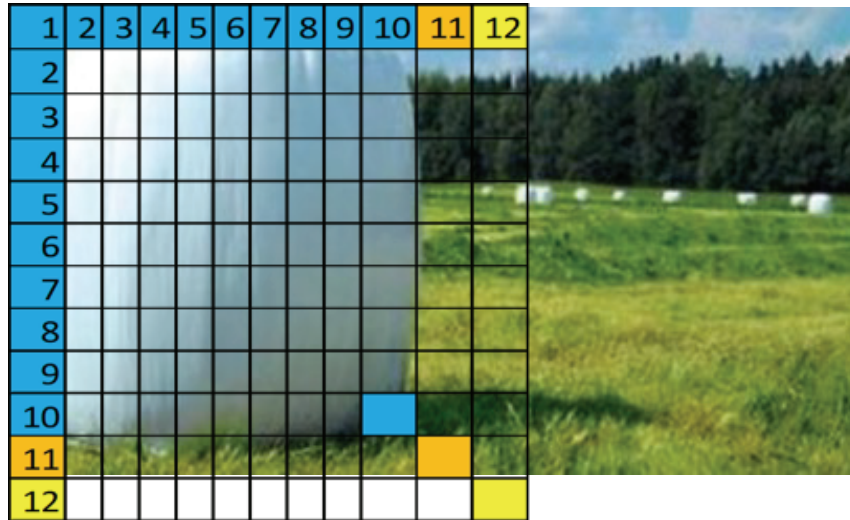
- If the material is overstretch by ONLY 10%, material surface increases by 21%.
- This would reduce tack level by 21%.
- If the material is overstretch by 20% (12x12= 144) tack level would decrease by 44%
 - This would give you the impression that the material has no tack while wrapping.

10 x 10 = 100	Excellent Coverage and Tack Levels
11 x 11 = 121	Increase Surface Coverage and Decrease Tack Levels by 21%
12 x 12 = 144	Increase Surface Coverage and Decrease Tack Levels by 44%

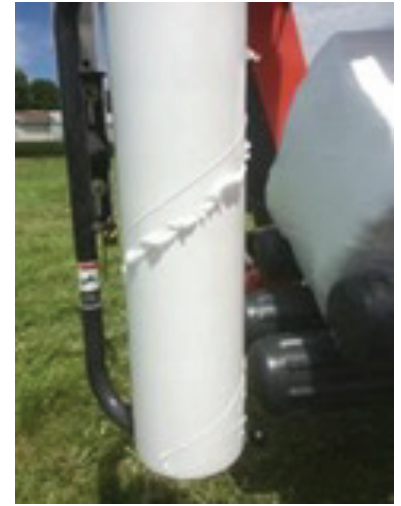
Spiral Tearing of Film

Does the edge of the roll have any damage?
