TROUBLESHOOTING GUIDE

Sigma Agriculture

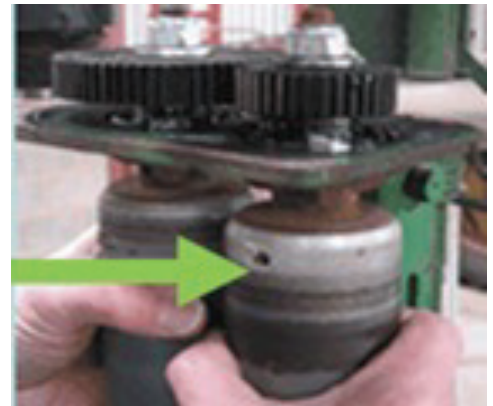
Roller Build Up

Issue: Over time, the tackifier used in silage film will rub on to the rollers of the machine causing the rollers to be covered in a sticky, black residue.

Solution: Clean rollers with white mineral spirit or automotive brake cleaner. Make sure that all build up has been removed from the rollers and retest.

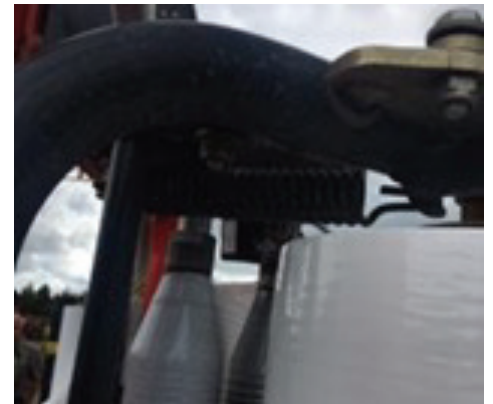
Are the springs in the pre-stretch unit weak?

Issue: The springs inside the pre-stretch unit will weaken or break over time. This can cause lack of tension on film during application.

Solution: Replace the weak springs in the pre-stretched unit to remove slack in the system.

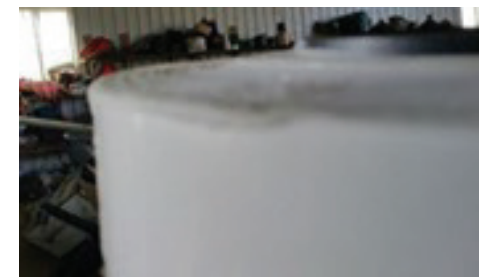
Is the edge damaged?

Issue: The roll was mishandled and has damaged. When rolls are dropped or damaged on the edge, the chance of film breaks increases dramatically.

Solution: Either pull the damaged film off the roll until undamaged film is exposed or replace the roll.

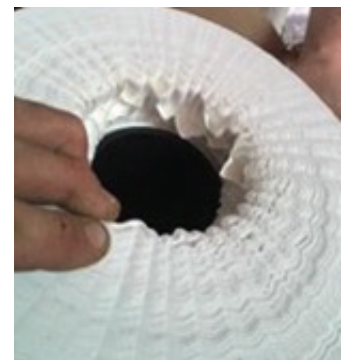
Is the film wound in a manner that makes it unusable?

Issue: Some of the ingredients used in the film can cause layers to slide between each other.

Solution: Unwind the film until any flaws have been removed. Try the roll again after unwinding. If the film is still unusable, please email us for technical assistance.

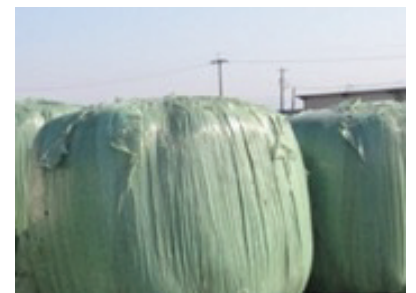
UV Degradation

Issue: Ultraviolet light, oxygen, and heat all will degrade polyolefins and cause brittleness, color change, and product failure. However, there are additives called Ultraviolet Inhibitors that trap the free radicals which form during the photo-oxidation process, retarding the breakdown of the film. However, over time, the sun degrades the UV Inhibitors in the plastic.

Solution: The plastic is guaranteed for a period of 12 month from the date of proper application and use. If the film is showing signs of degradation within this warranty period, please contact technical support. Please be sure to include a detailed description of your issue, your contact information any photos you have, the core number and roll number of the film.
